Building Performance Evaluation Final report

Camden Passive House

Camden Passivhaus

Technology Strategy Board BPE ref no:	4638-31202
Project title:	Camden Passivhaus
Lead organisation name:	Bere Architects
Number of properties part of BPE:	1
BPE project type (phase 1 or 2)	Phase 1

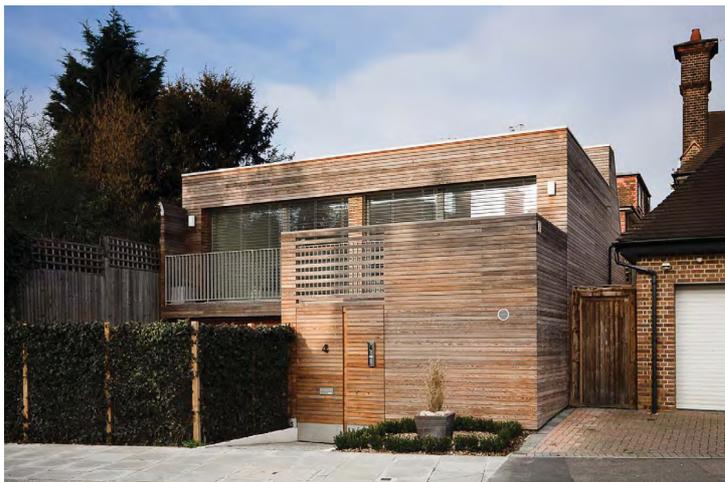
The house is a modern, timber-clad design with exceptionally low heat loss and excellent air tightness

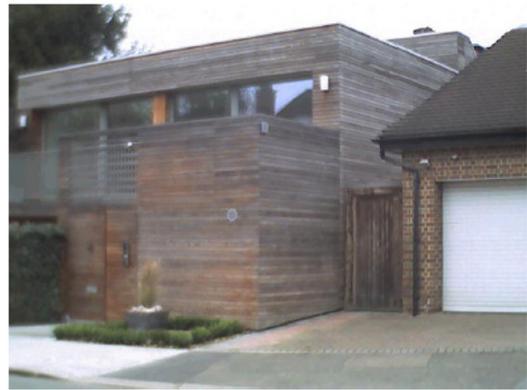
There is minimal heat loss through the walls – although surface temperatures are very low because of the air gap behind cladding

The survey showed surface temperatures for the walls as almost exactly the same as ambient temperature, but this was at least partly due to the air gap between timber cladding and the insulation behind. Windows had a slightly higher surface temperature – 13 °C (1.4 °C higher than the surrounding wall elements) – showing that even triple glazing does not completely prevent heat loss through glass. (Some caution is needed when comparing surface temperatures of glass and timber because of different emissivity and absorption of moisture.)

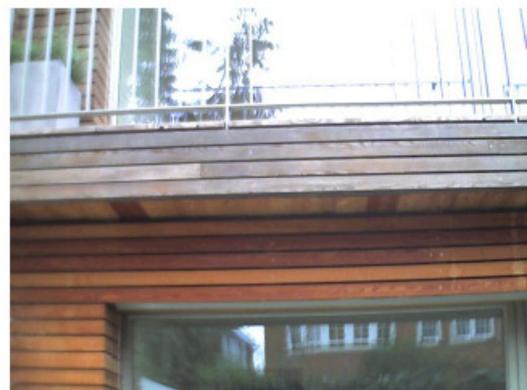
The only significant area of heat loss is the perimeter of windows – the frames and window reveals were 14 °C. This is low heat loss compared to standard construction details and double glazed units.

The study showed that the edges of windows have unavoidable heat loss compared to the very high performance wall. Nevertheless the psi values are 0.010-0.020W/(mK), which are very low. Even here, though, the surface temperature was only two or three degrees above ambient temperature.

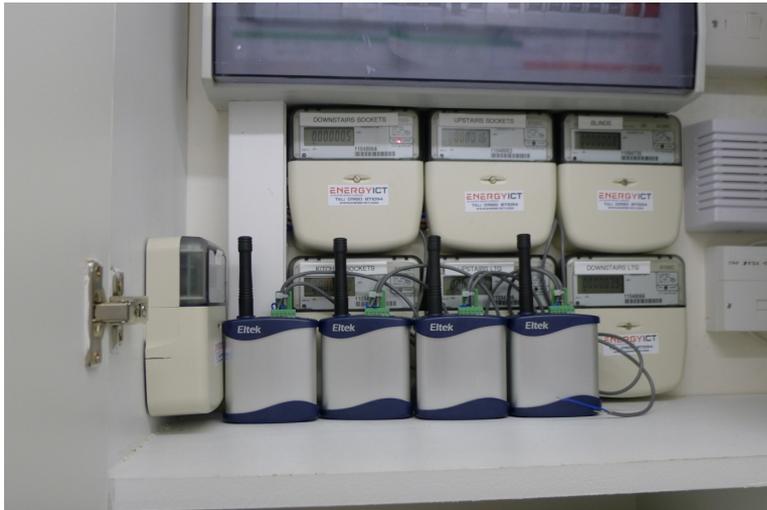
Electrical sub-meters were fitted with wireless transmitters to connect them to Eltek's datalogger.
