# Building Performance Evaluation

### Phase 1: Post construction and early occupation

Larch House and Lime House, Ebbw Vale

<b>Technology Strategy Board BPE ref no:</b>	450019
<b>Project title:</b>	Future Works Passivhauses
<b>Lead organisation name:</b>	Bere Architects
<b>Number of properties part of BPE:</b>	1
<b>BPE project type (phase 1 or 2)</b>	Phase 1

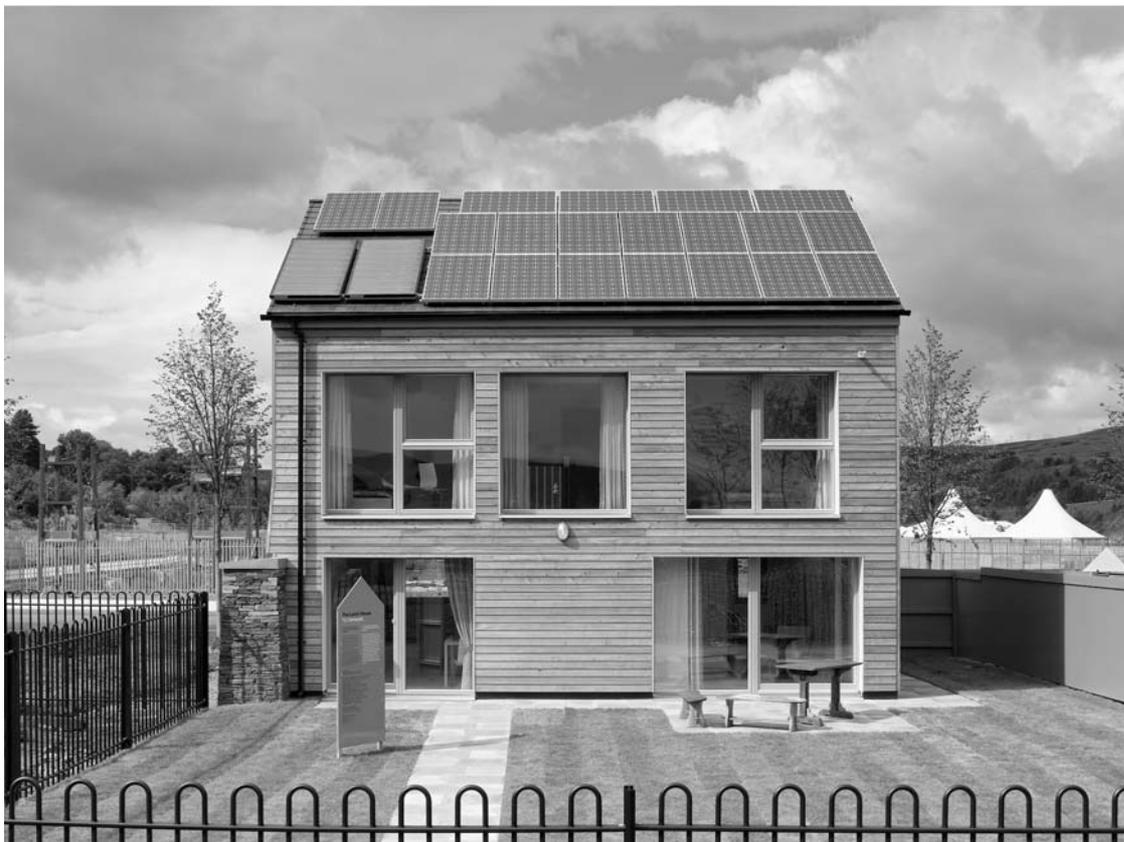
*Larch House is a modern, timber-clad design with exceptionally low heat loss and excellent air tightness*

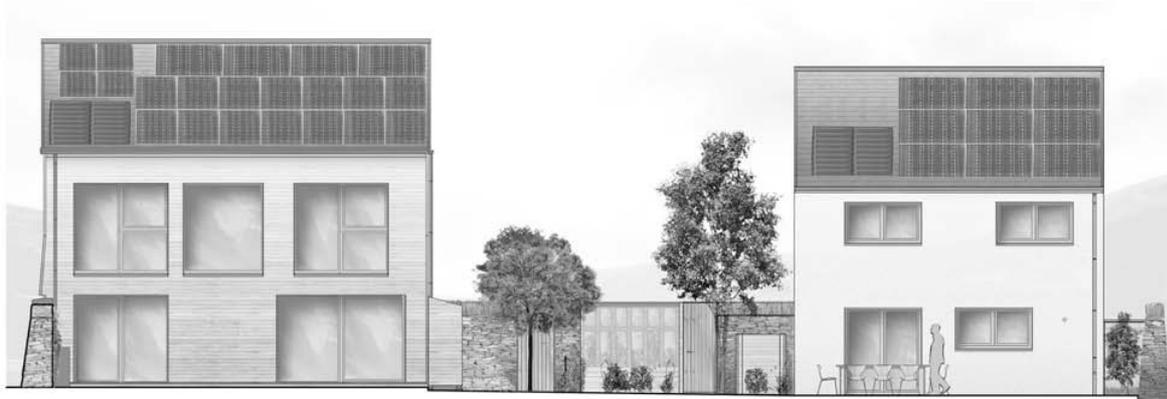
*These elevations show Larch House's much higher glazing ratio (55%) on the south side, compared to Lime House's 20% south-side glazing ratio. The difference is down to different weather data used for certification.*

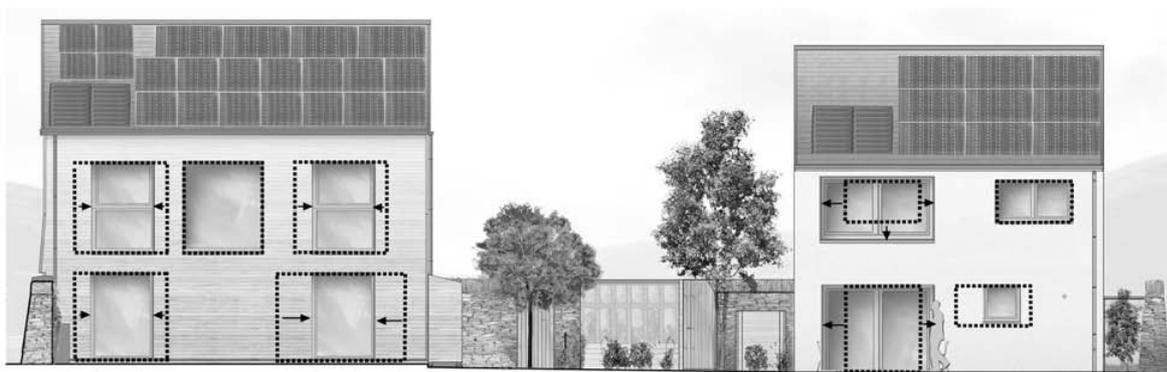
*Using Manchester mean weather data, which is milder and less cloudy, would have allowed certification for a 33% glazing ratio for the south side of both homes. This would also have allowed a cheaper fabric specification.*

When Bere re-designed the two houses with average (Manchester) weather data they found that this significantly reduced or even eliminated the difference between using 'annual heat demand' and 'peak load' in certification. Both certification methods allowed 33% south-facing glazing and an identical (reduced) fabric specification compared to the houses that were actually built. PHPP indicates that internal blinds would be sufficient to maintain comfort in summer.

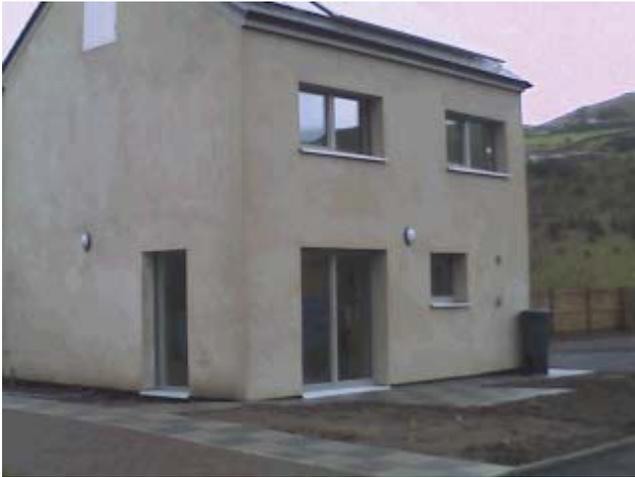
Modelling using Therm 5.2 found that the Internal Psi at this junction was 0.13, and the External Psi was 0.02 W/mK. This compared to an excellent modelled floor u-value of just 0.07 W/m<sup>2</sup>K. This suggests that the plinth is indeed a weak link in the fabric – partly because other parts of the building are so well insulated.

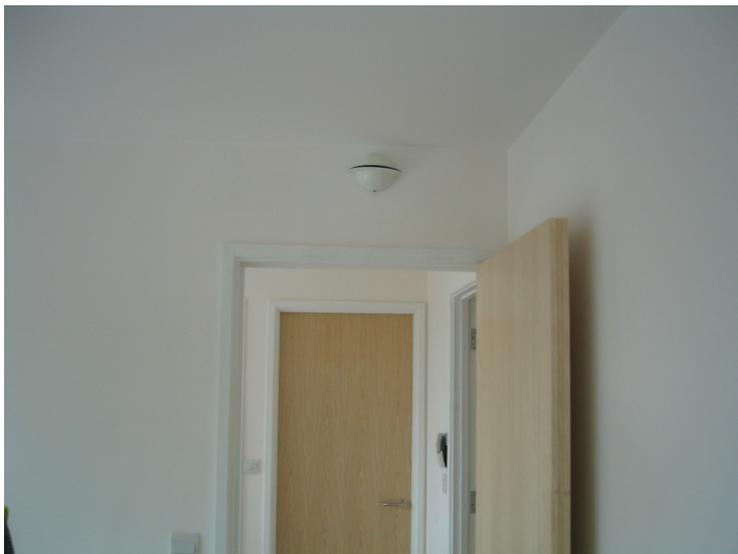
*Supply is over doors using a terminal designed to circulate the supply air across the room with the return path at low level under the door*

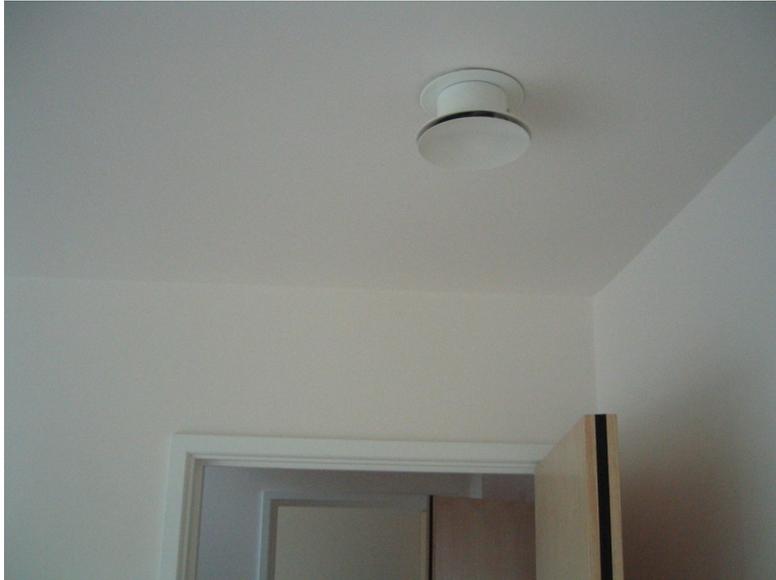
*On the ground floor directional ceiling mounted terminals are used to distribute air southwards across rooms from the duct zone at the north of the building*

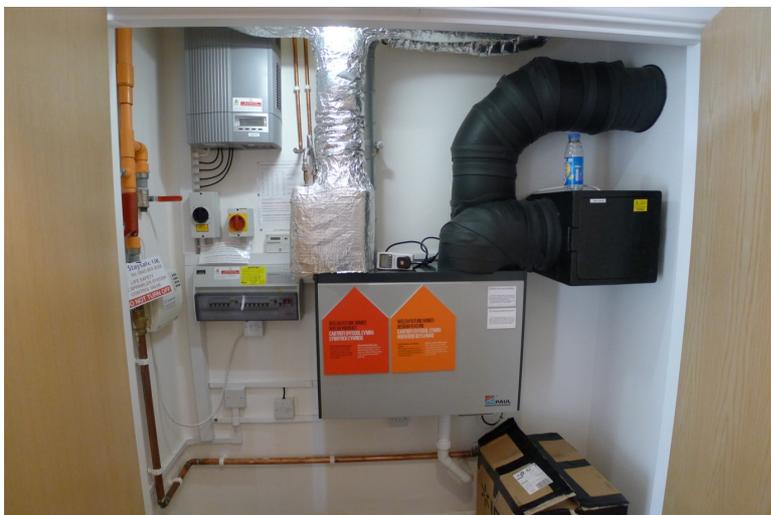
A heater battery is installed directly above the HRV and this is supplied with hot water from the central heating boiler (a Rehema Avanta 18s) in the airing cupboard upstairs. The heater battery is on the left of the picture below, with foil-covered insulation. The intake and exhaust ducts are on the right and insulated with vapour-impermeable Armaflex insulation. The frost heater and pre-filter are in the black insulated box on the right.

*The HRV draws air in from outside through the black frost heater (right), pushes it through a foil-covered heater battery and around the house*

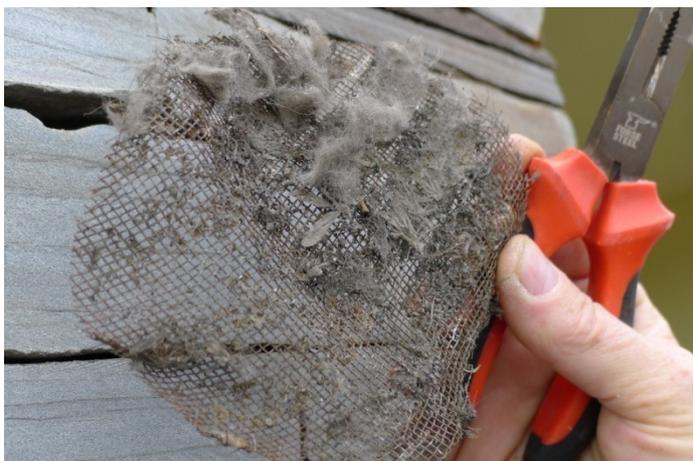
1. Insect screens in the intake louvres were badly blocked (see photo below). The constant volume fans were running noisily to compensate for the extra pressure loss. The screens were built into the external terminals and could not be accessed for cleaning team decided to remove them, relying instead on the easily-replaceable pre-filter to remove fluff and insects as this filter will be changed regularly.

*Built-in insect screens in the external intake terminals were hard to access and became blocked. The project team removed them and relied on the pre-filters to remove insects.*

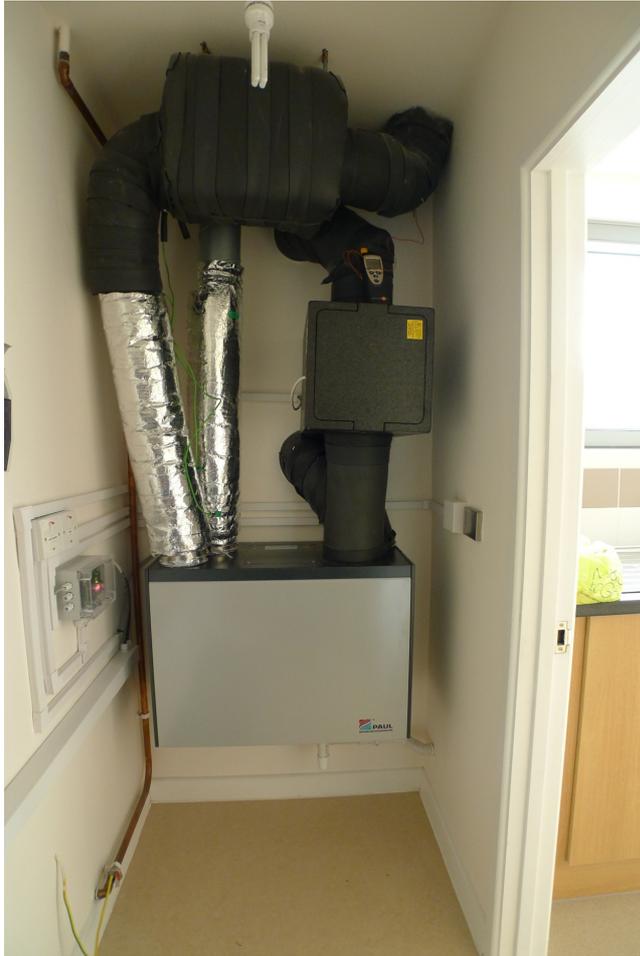
*Incoming air enters the HRV from the back wall, towards the top, via the frost heater to the right. It passes through the heat-exchanger in the HRV, and then on through the heater battery at the top near the ceiling. Then it circulates around the house, to return as extract air through the vertical duct towards the back. Finally extract air passes once more through the HRV unit to leave the house through the lower duct in the back wall.*

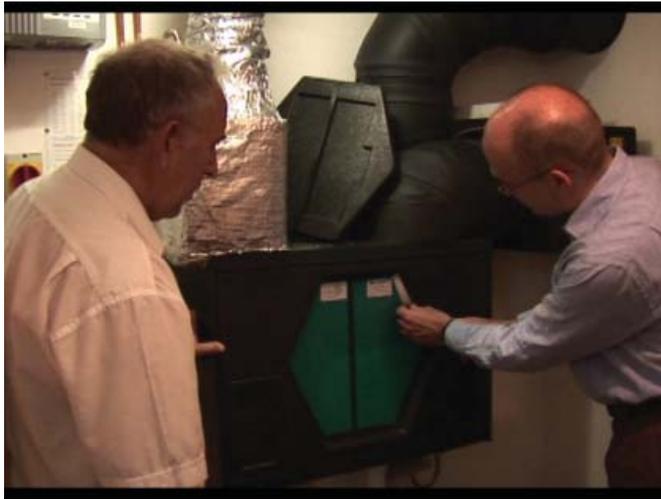
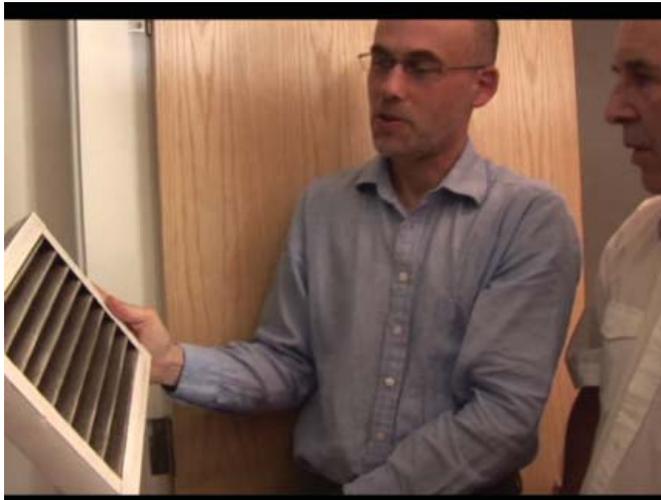
The Soft Landings event included a demonstration of the HRV (above), and how to change the filter (below), and it was filmed by Splash TV

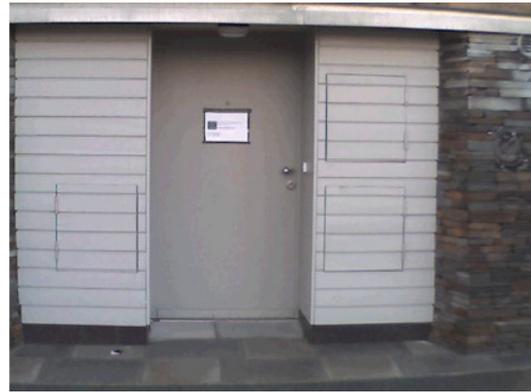
*There were problems with air tightness of Larch House's front door after it was damaged on site, and even after a 'Plano' insert was used below the door, further adjustment is still needed to pull the door against its seals*

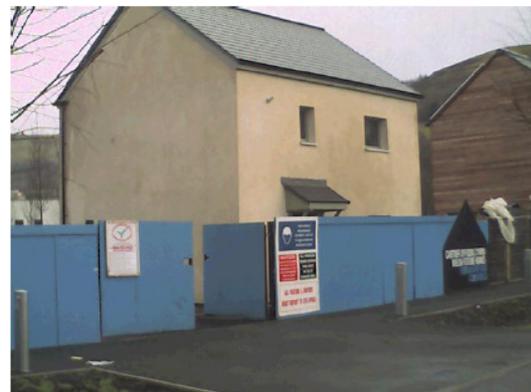
*In Lime House too, the windows and plinth had higher surface temperatures than the walls – a 3 or 4°C difference*

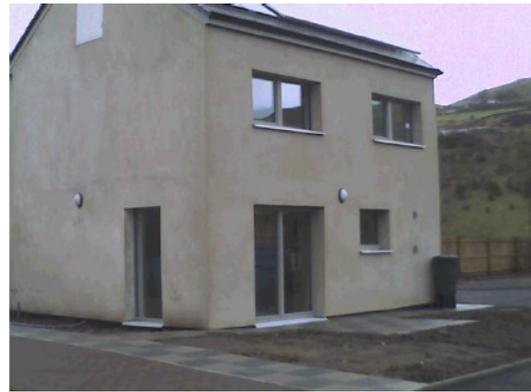
*The south side (right) of Lime House is 1.2°C warmer than the west side (left) too, once again the effect of diffuse sunlight even on a cloudy day*

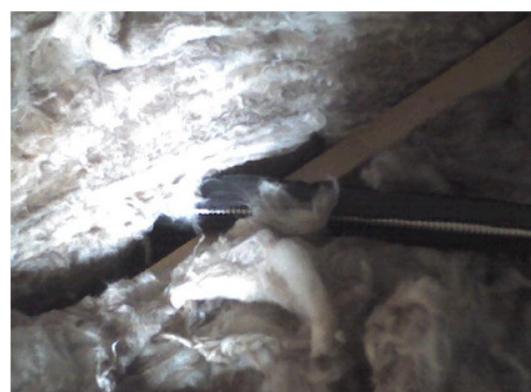
*Examining the loft indicated that lagging had been moved to accommodate plumbing for the solar water heating*

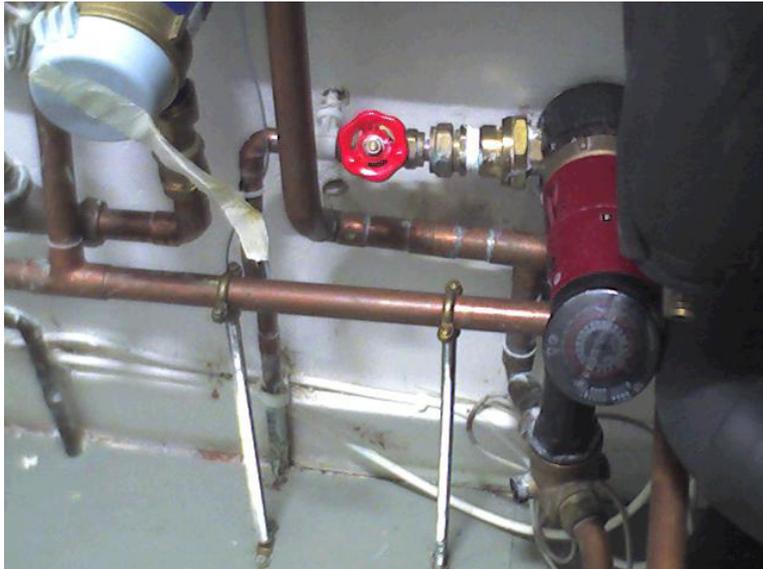
*Short sections of inadequately lagged pipework was also leading to heat loss (although this is by no means unusual in new heating installations)*

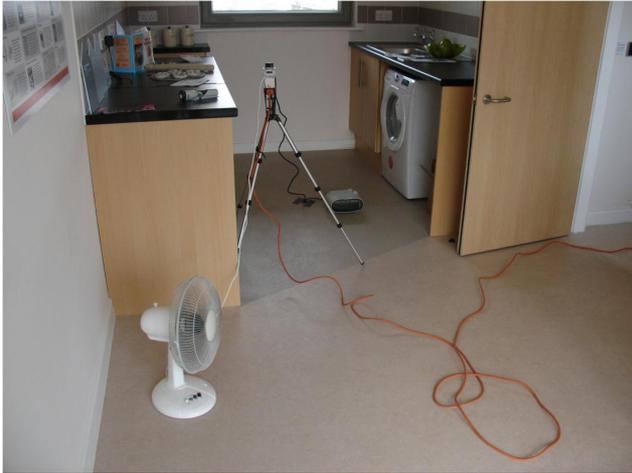
*Temperature monitoring equipment set up in Larch House during the co-heating test*

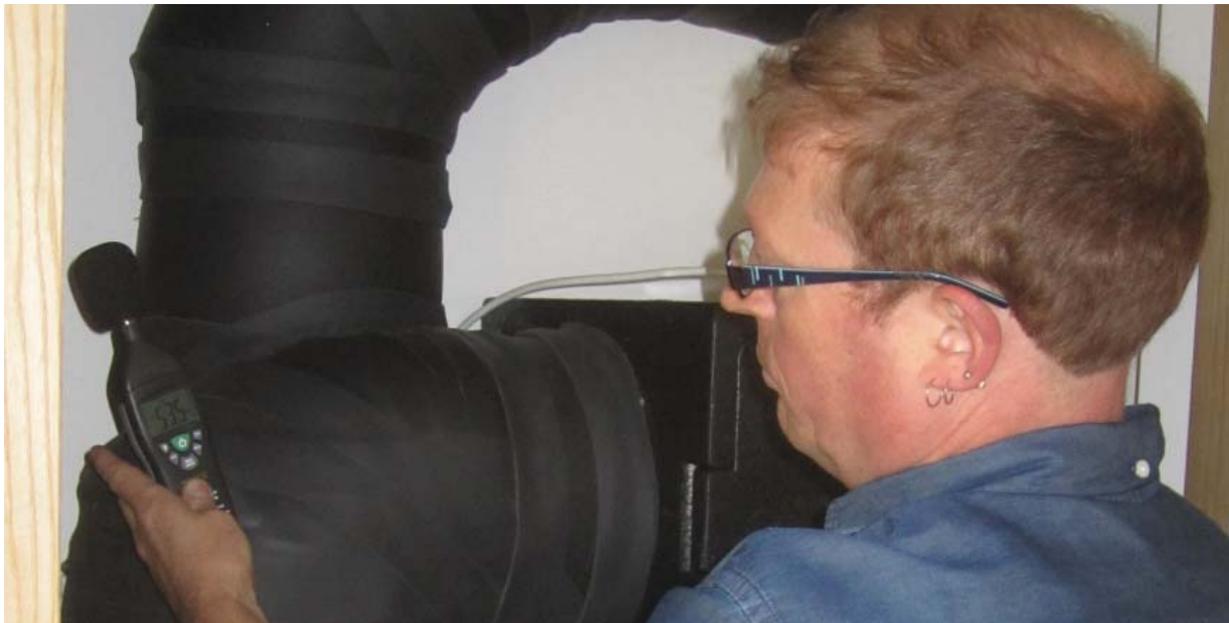
After rigorous fabric testing with the airtightness and other tests, the heat recovery ventilation unit was checked to ensure the system was balanced, and that everything was still performing correctly.

This re-commissioning was performed by Andrew Farr, a ventilation systems expert from the Green Building Store, responsible for the original supply of this energy saving system. The visit highlighted just how much construction site dust and dirt had been trapped by the building's air filtration system during the six months since the building's completion, and that cleaning the filters was a simple way to keep the building's indoor air quality at a very high standard.

Green Building Store's Andrew Farr re-balanced the HRV after airtightness and other system tests

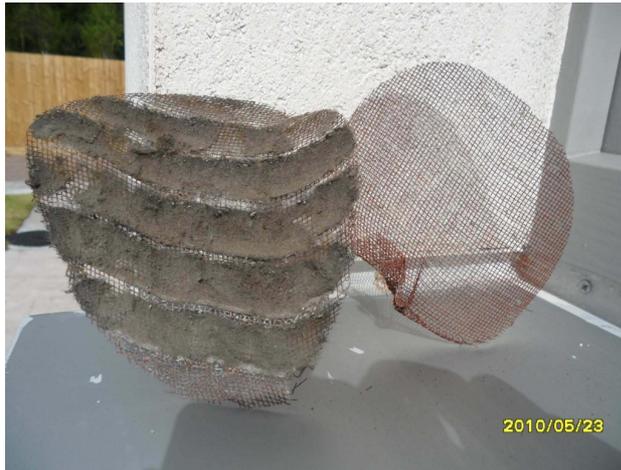
The intake mesh (left) for the HRV was blocked with debris, while the and exhaust mesh (right) was clean

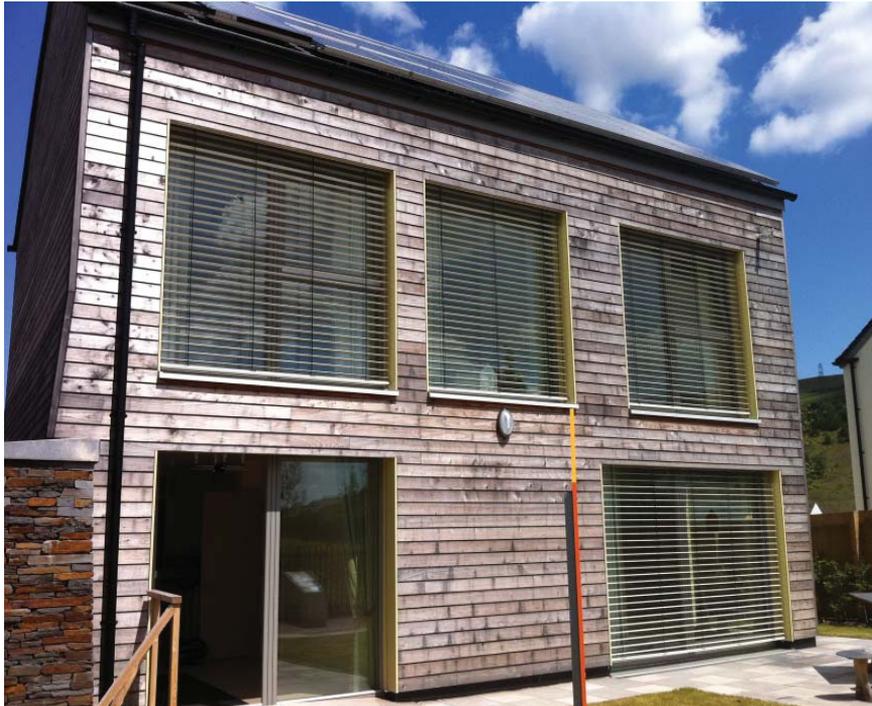
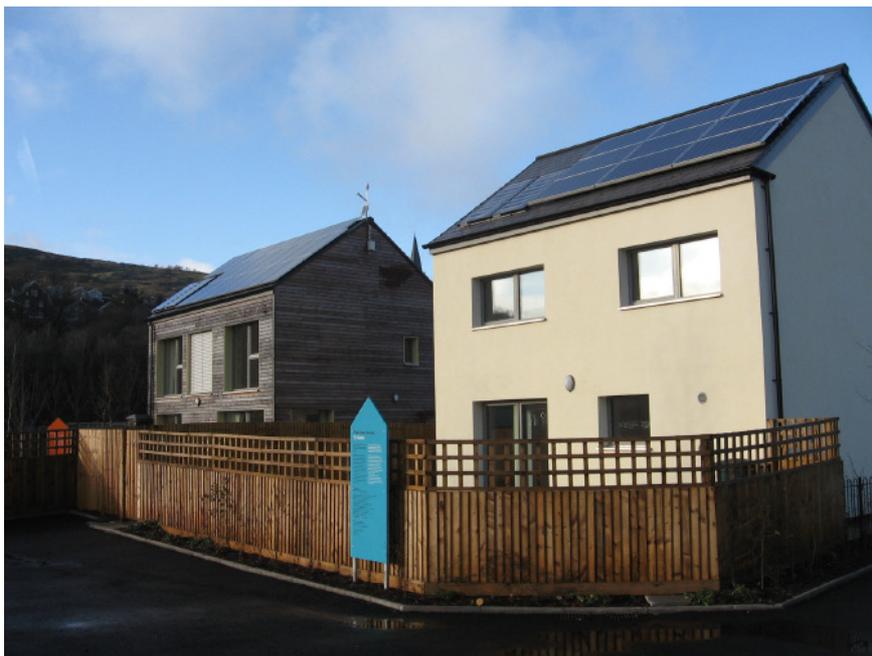
*The Larch House south façade is highly glazed with external shading to reduce overheating.*

*Lime House (right) has smaller windows on the south side, and is rendered. Both houses have solar water heaters and a PV array on the roof. (Photo: Tim Crocker)*
